Inspection Report

Sample Report

Property Address:
123 Sample Report Drive
Lake St. Louis MO 63367

Mitchco Home Inspection Services

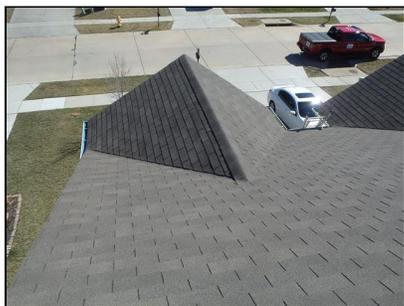
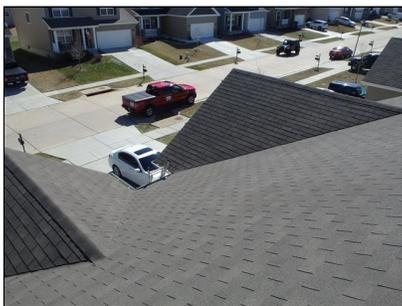
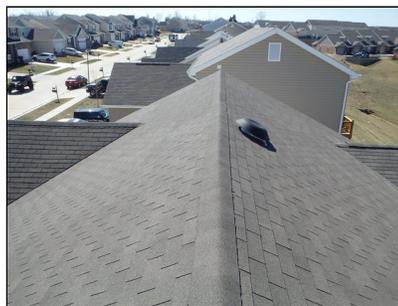
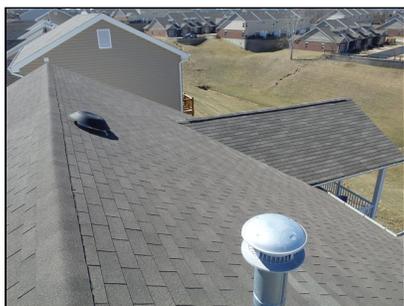
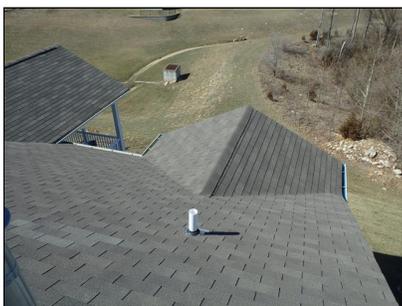
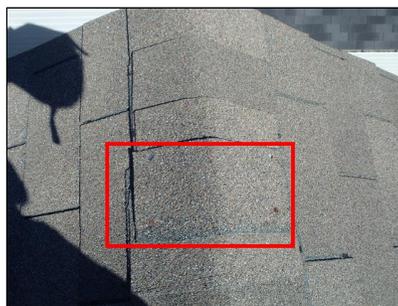
Three tab roof covering is approximately 4 to 5 years old, with a design life of 18 to 24 years. Shingles exhibit a moderate degree of wear. Typical condition for the age, however no broken or cracked shingles were observed. Exposed nails on the peak at right side. Recommend applying caulk over them. Also, no active water penetration into attic was observed at the time of inspection. Recommend to monitor condition of roof in the future and repair/ replace as needed.

- 1) Exposed nails should be caulked to eliminate water penetrating under them.
- 2) All vent pipe flashings should be checked periodically and should be repaired and/or sealed as needed.

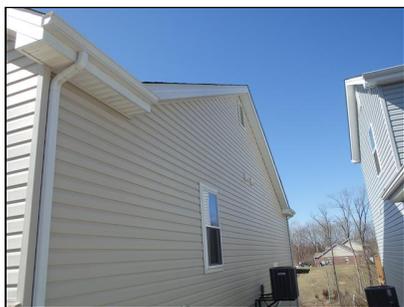
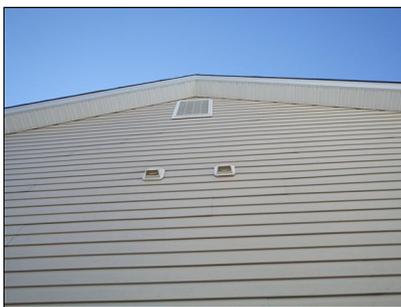
A microbial or mildew growth is on the siding on the front and right side of the home. Recommend cleaning the surfaces to prevent deterioration of the siding. Have a qualified contractor review and give an estimate to clean the siding.

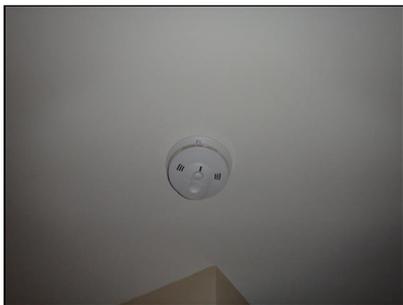
8.8 Item 1(Picture)

1) The presence of one or more smoke detectors was observed in the house. It is recommended that the detectors be tested monthly and batteries changed yearly.

2) There were no carbon monoxide detectors observed in the house. It is recommended that one be installed according to the manufacturer's instructions.

3) When installing or upgrading detectors it is recommended that Photo Electric style be installed. Replace all units at least every 10 years or according to manufacturing recommendations.

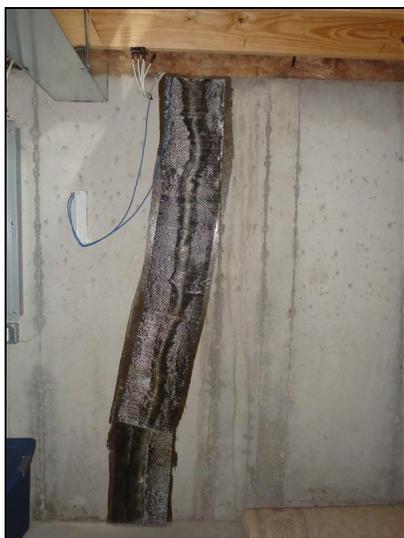
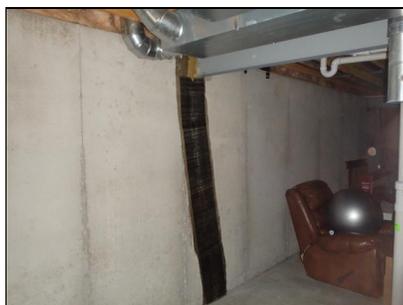
1) Two cracks have been professionally repaired. No unusual issues were observed. Repair as needed if a water penetration situation appears. These repairs usually have lifetime warranties or guarantees. Have transferred to new owners after closing.

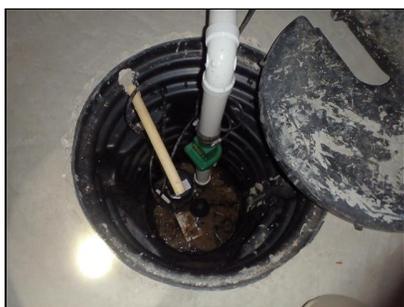
10.2 Item 1(Picture)

Sump pump could not be checked or operated during the inspection. The pump could not operate without adequate water in the pit. Recommend checking pump regularly and after weather events to ensure proper operation.

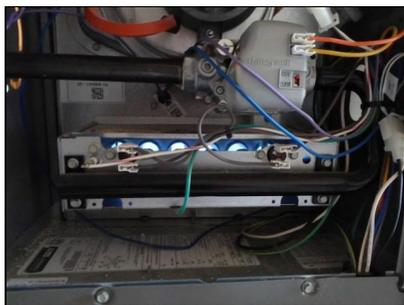
11.1 Item 1(Picture)

The "Heart" of a furnace is a metal chamber referred to as a heat exchanger. All or most areas of this exchanger are not readily accessible or visible to a home inspector. Therefore, a assessment of a furnace is limited to external and operational conditions. The older the unit, the greater the probability of significant deterioration of failure. A thorough inspection by a qualified HVAC technician is advised for full evaluation of the heat exchanger, particularly if the unit is beyond 5+ years old or any wear is noticed. Filters should be checked monthly. Replace as needed.

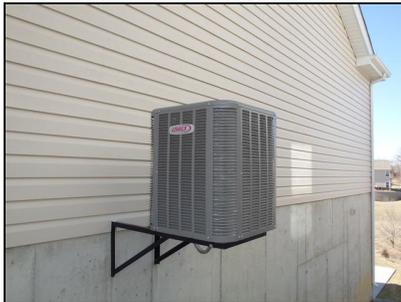
12.5 Item 1(Picture)

Cooling fins must be kept clean and free of dirt, debris and vegetation. Blockage and vegetation around the outside unit can affect the efficiency and life expectancy. Recommend contacting a qualified HVAC technician if questions arises or conditions change.
